Manhole Inspection Summary

Manhole # S39G__008MH

Location Address: **e lombard st**

Cross Street: **s. albemarle st**

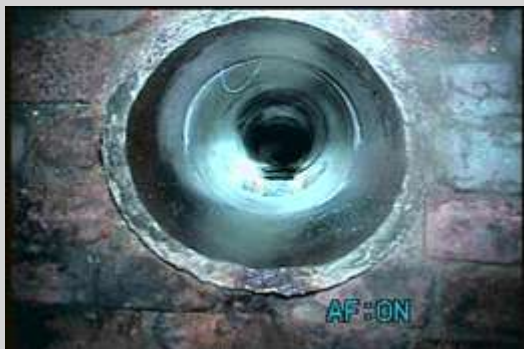
6 O'Clock Inflow

Pipe Height: 0 (in.) Direct

Pipe Material: **Clay** ☐ Pipe Lined

Invert Depth: **11.58** (ft.) Flow Characteristics: **Slow**

Infiltration: **None** Pipe Seal Cond: **Unknown**

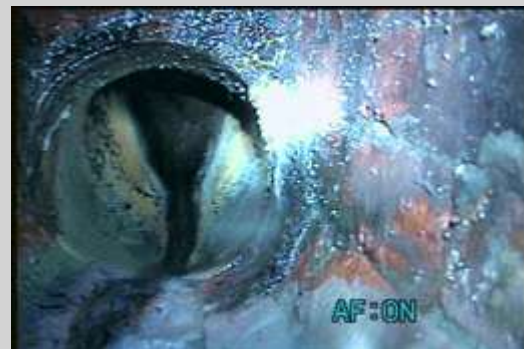
Drop In @ 6 O'Clock

Drop: **Outside Direct**

Inv Depth: **17.10** (ft.)

Drop Condition: **Open**

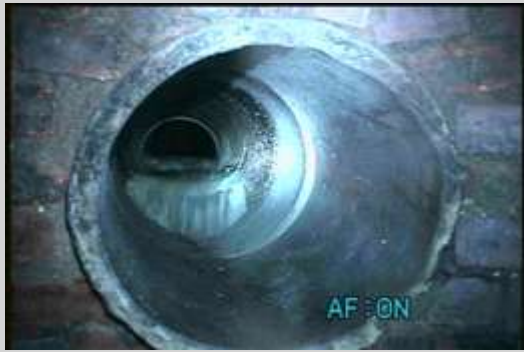
9 O'Clock Inflow

Pipe Height: 0 (in.) Direct

Pipe Material: **Clay** ☐ Pipe Lined

Infiltration: **None** Pipe Seal Cond: **Unknown**

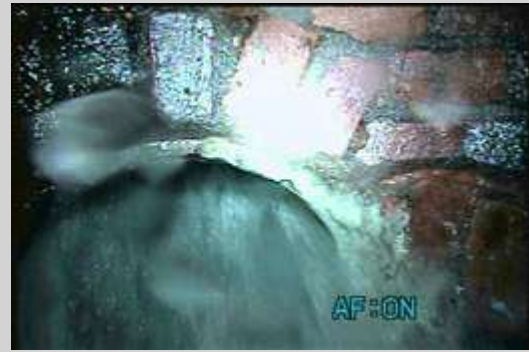
Drop In @ 9 O'Clock

Drop Condition: **Open**
